010C WIND SPEED SENSOR

SERVICE MAINTENANCE, REPAIR, SPARE PARTS

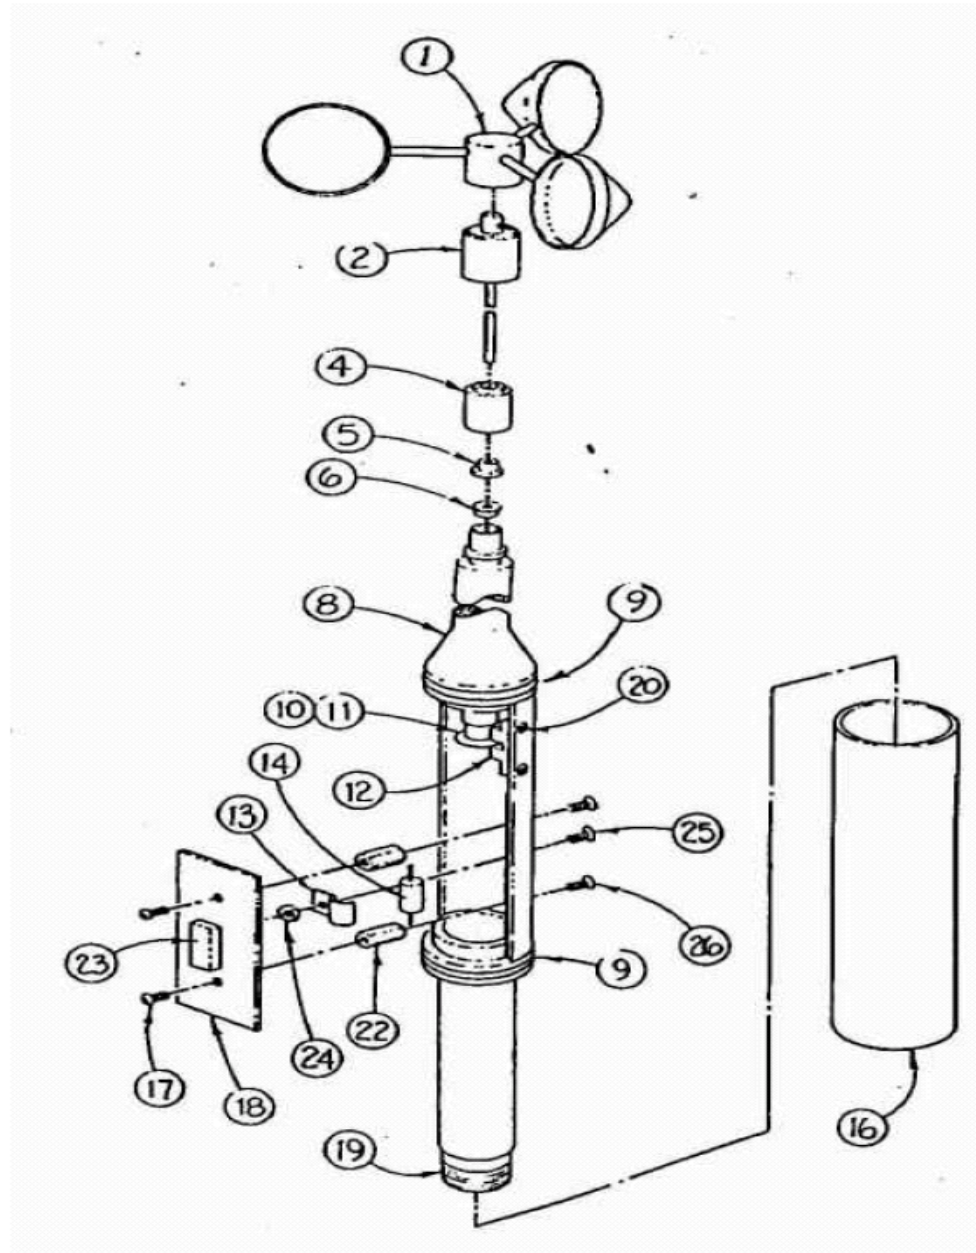
ASSEMBLY/PARTS REFERENCE DRAWING

Ref#	PART #	DESCRIPTION
1	2672	CUP ASSEMBLY, LEXAN (010C)
1	2672-1	CUP ASSEMBLY, ALUM. (010C-1)
2*	2658	HUB/SHAFT ASSY
4*	1009	SHIELD WS/WD
5*	1010	SLINGER WS/WD
6*	1055	BEARING
9	720120	O RING
10	2202	CHOPPER ASSY
11	601250	SET SCREW
12**	1074	DETECTOR ASSY.
12**	520253	PHOTO DETECTOR, 011 E-CLASS WS SENSOR
13	480100	HEATER CLAMP
14	805080	RES. 5W 1% 35 OHM WW
16	2675	SENSOR COVER
17	601240	SCREW, PAN HD PHIL 4-40 X 1/4" SS
18	1200-1	PCBA WS
20	601270	DETECTOR ASSY. MOUNTING SCREWS
22	860050	STANDOFF
24	600400	NUT, HEX KEP 4-40
25	601330	SCREW, 4-40 X 3/8, F.H., PHIL., SST
26	601240	SCREW, PAN HD PHIL 4-40 X 1/4" SS

Note: Replacement of some of the following parts will require re-calibration of the sensor. Those replacement items that require re-calibration of the sensor are indicated with an " * ". Instructions are provided in the Product User's Manual.

****Note: Serial number M10560 and later uses P/N 520253 Detector. Earlier models use P/N 1074**
